# Stormwater Management Ponds

## Township of Uxbridge

Stantec conducted an assessment of twenty two (22) stormwater management (SWM) facilities within the Township of Uxbridge in 2012 to assist the Township in prioritizing maintenance activities.

**Stormwater Management Pond Example:**  
SWM Pond 1E, Industrial Park East

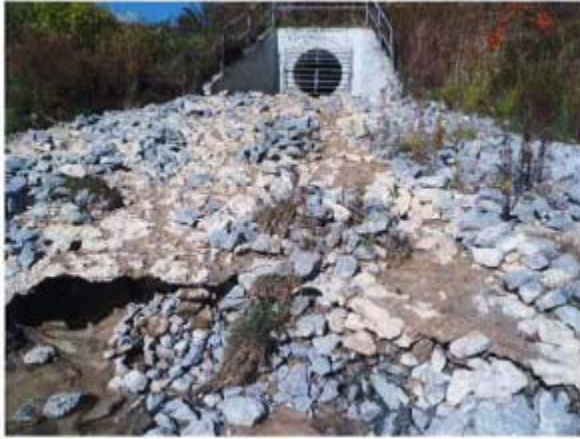
Signage	Has a SWM pond warning sign been installed? Any other signage related to SWM?	No	
Fencing	Has a safety fence been installed around the pond? Is there a locked gate prohibiting access?	No	
Sediment Drying Area	Has an area been provided for sediment de-watering?	No	
Inlet Structures	Structural integrity of headwall/pipes (cracked, broken, separated, grate secure, etc.) Are pipes clear of debris and/or sediment? Is there erosion protection? If so, what is the approx. mean diameter of the stone? (Photo document)	Yes	The pond has three inlets , two storm sewer inlets, east and west headwall, as well as a culvert inlet, central headwall. The east inlet headwall is in good repair, pipe is free of debris, the pedestrian handrail is secure, however, the grate is loose and needs to be tightened. The erosion protection for this headwall consists of rip rap embedded in concrete, a lot of the rip rap has been dislodged and at the waters edge, the ground beneath the concrete has been eroded leaving a gap between the ground and the concrete. The central headwall (box culvert) is in good repair, grate and pedestrian handrail secure.

East inlet headwall, Erosion protection

Maintenance Recommendations		
<p><b>Required</b></p> <p>The pond appears to require a full sediment cleanout. Obtain a sediment survey to confirm the quantity of sediment to be removed. Repair undermined erosion protection at east inlet headwall. Place more rip rap at east forebay berm to cover exposed erosion matting.</p>		
<p><b>Recommended</b></p>		
Major Maintenance Activities Completed		
Item	Date Completed	Comments
Sediment Cleanout		Volume Removed (Forebay/Aftbay): Cleanout Method: Disposal Location: Cost \$/m3: Other Comments:
Vegetation/ Landscape		
Structural Improvements		
Other

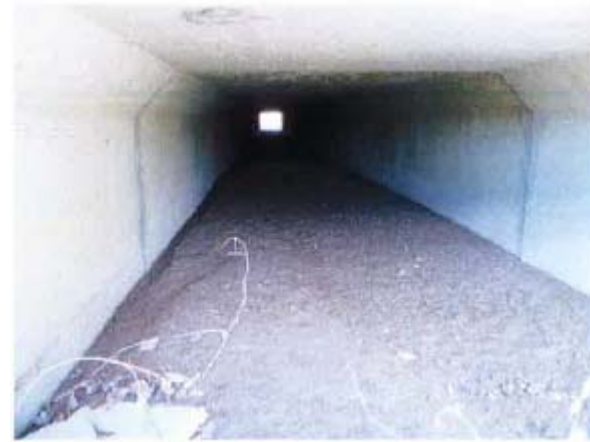
Item	Criteria/Maintenance Item	Y/N	Notes
Inlet Structures	Con't		There is approximately 0.3 m of accumulated sediment and vegetation growth within the headwall bottom (a tree is actually growing in it), the downstream side of the culvert has accumulated sediment in it (not measured as difficult to access), however the upstream side of the culvert has little sediment accumulated in it. Gabion baskets are located around the wing walls. No erosion protection visible. The west headwall is in good repair, grate and pedestrian handrail secure, there is a slight gap in the handrail which is corroding however as mentioned it is still secure. Inlet pipe is clear of debris, however, some minor sediment accumulation at wingwalls. Some erosion protection visible beneath the water surface.
Overland Flow Route	Is the facility equipped with an overland flow route? If so, is it in good repair? Vegetated or hardened? (Photo document)	No

Central headwall culvert

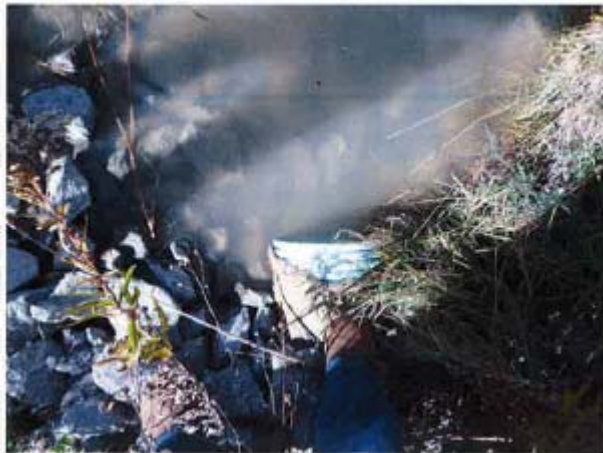
Infiltration Basin	Is the facility equipped with an infiltration basin? If so, describe.		
Outlet Structure	Are there any visible control structures (hickenbottom riser pipe, orifice plates/tubes, DICB grates, etc.) If so, what are their condition? Is outlet headwall/pipe clear of debris and/or sediment? Is there erosion protection? If so, what is the approx. mean diameter of the stone? (Photo document)	Yes	The outlet structure is comprised of a 200mm PVC inlet pipe, a DICB MH (grate is sloped and it's dimensions are 0.6 m wide x 1.2 m) and CMP outlet pipe complete with a rip rap plunge pool (located on south side of Highway 47). All of which are in good repair.
Emergency Spillway	Is the facility equipped with an emergency spillway? If so, is it in good repair? Vegetated or hardened? (Photo document)	No	
Permanent Pool Water Level	Is the pond level higher than the normal permanent pool elevation > 24 hrs after a storm? Is the pond level lower than the normal permanent pool elevation? What are possible causes for water level (blocked inlet/outlet)?		Water level is normal.

Outlet Structure, Quality Control Pipe

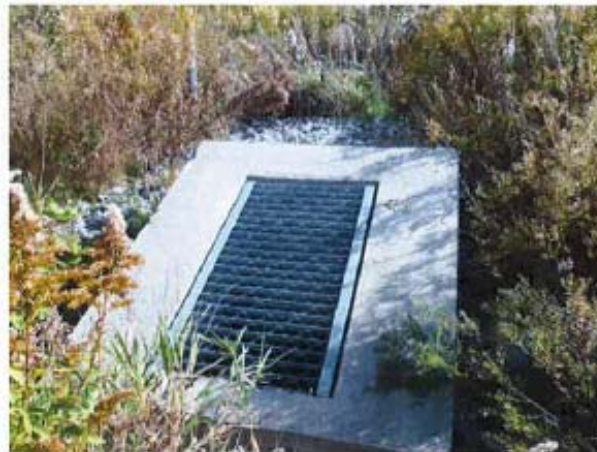
Outlet structure, DICB

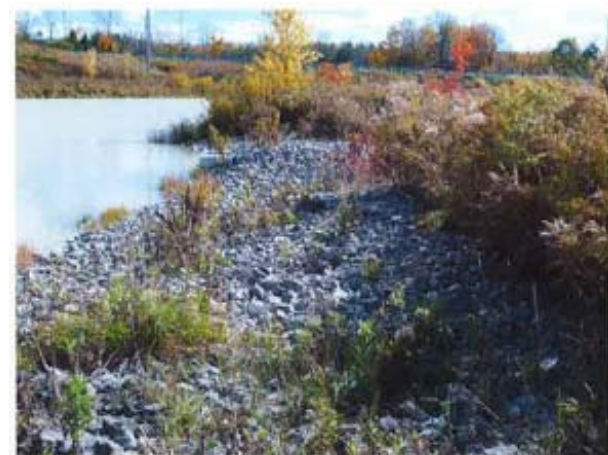
Item	Criteria/Maintenance Item	Y/N	Notes
Forebay/Aftbay	Is there a defined forebay and aftbay? Is there a forebay berm? If so, is it submerged? (Photo document)		There are two defined forebays and one aftbay between the two. The forebay berms are raised, lined with rip rap on the downstream side (adjacent to the aftbay). Vegetation is growing within the rip rap and some erosion matting is exposed on the east berm. Each berm is equipped with two PVC pipes, on the upstream side of the berm the pipes are fully submerged and on the downstream side the pipe inverts are set at the normal water level. All the pipes are in good condition.
Permanent Pool Water Depth	Approximate permanent pool depth? Is there significant sediment accumulation in the forebay? Aftbay? Estimated depth of sediment in the forebay? Is a sediment cleanout likely necessary?		The permanent pool is deep. At the east inlet headwall, a lot of sediment has accumulated (up to normal water level). There is some accumulation at the west inlet headwall but not as much.

Forebay berm
