**HYDROGEOLOGICAL INVESTIGATION  
150 CEMETERY ROAD  
UXBRIDGE, ONTARIO  
L9P 1R1**

**REPORT NO.: 5431W-20-HB  
REPORT DATE: February 10, 2021  
REVISION NO.: 00**

**PREPARED FOR:  
CORAL CREEK HOMES  
1 BROWNSCOMBE CRESCENT  
UXBRIDGE, ONTARIO L9P 1X9**

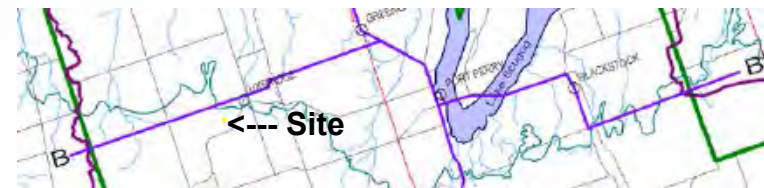
FIGURE NO: 7

TITLE: Regional Hydrostratigraphic Cross-Section

A conceptualization of the regional hydrostratigraphy through the subwatershed in a west-east direction is depicted in **Figure 7**. The cross-section illustrates the hydrostratigraphic profile through the subwatershed which was adopted for regional groundwater flow modelling studies in the subwatershed (Earthfx, 2006). The section is offset from the Site by approximately 1.5 km north. A description of each hydrostratigraphic unit depicted in **Figure 7** is provided below:

- **Sunnybrook Drift** – The Sunnybrook Drift was deposited approximately 45,000 years B.P. It is interpreted to be a silt and clay formation with a thickness of 10 m to 20 m, where present. Based on the hydrostratigraphic section of **Figure 7**, the Sunnybrook Drift is expected to be present at the Site at an approximate elevation of 200 masl (95 mbgs).

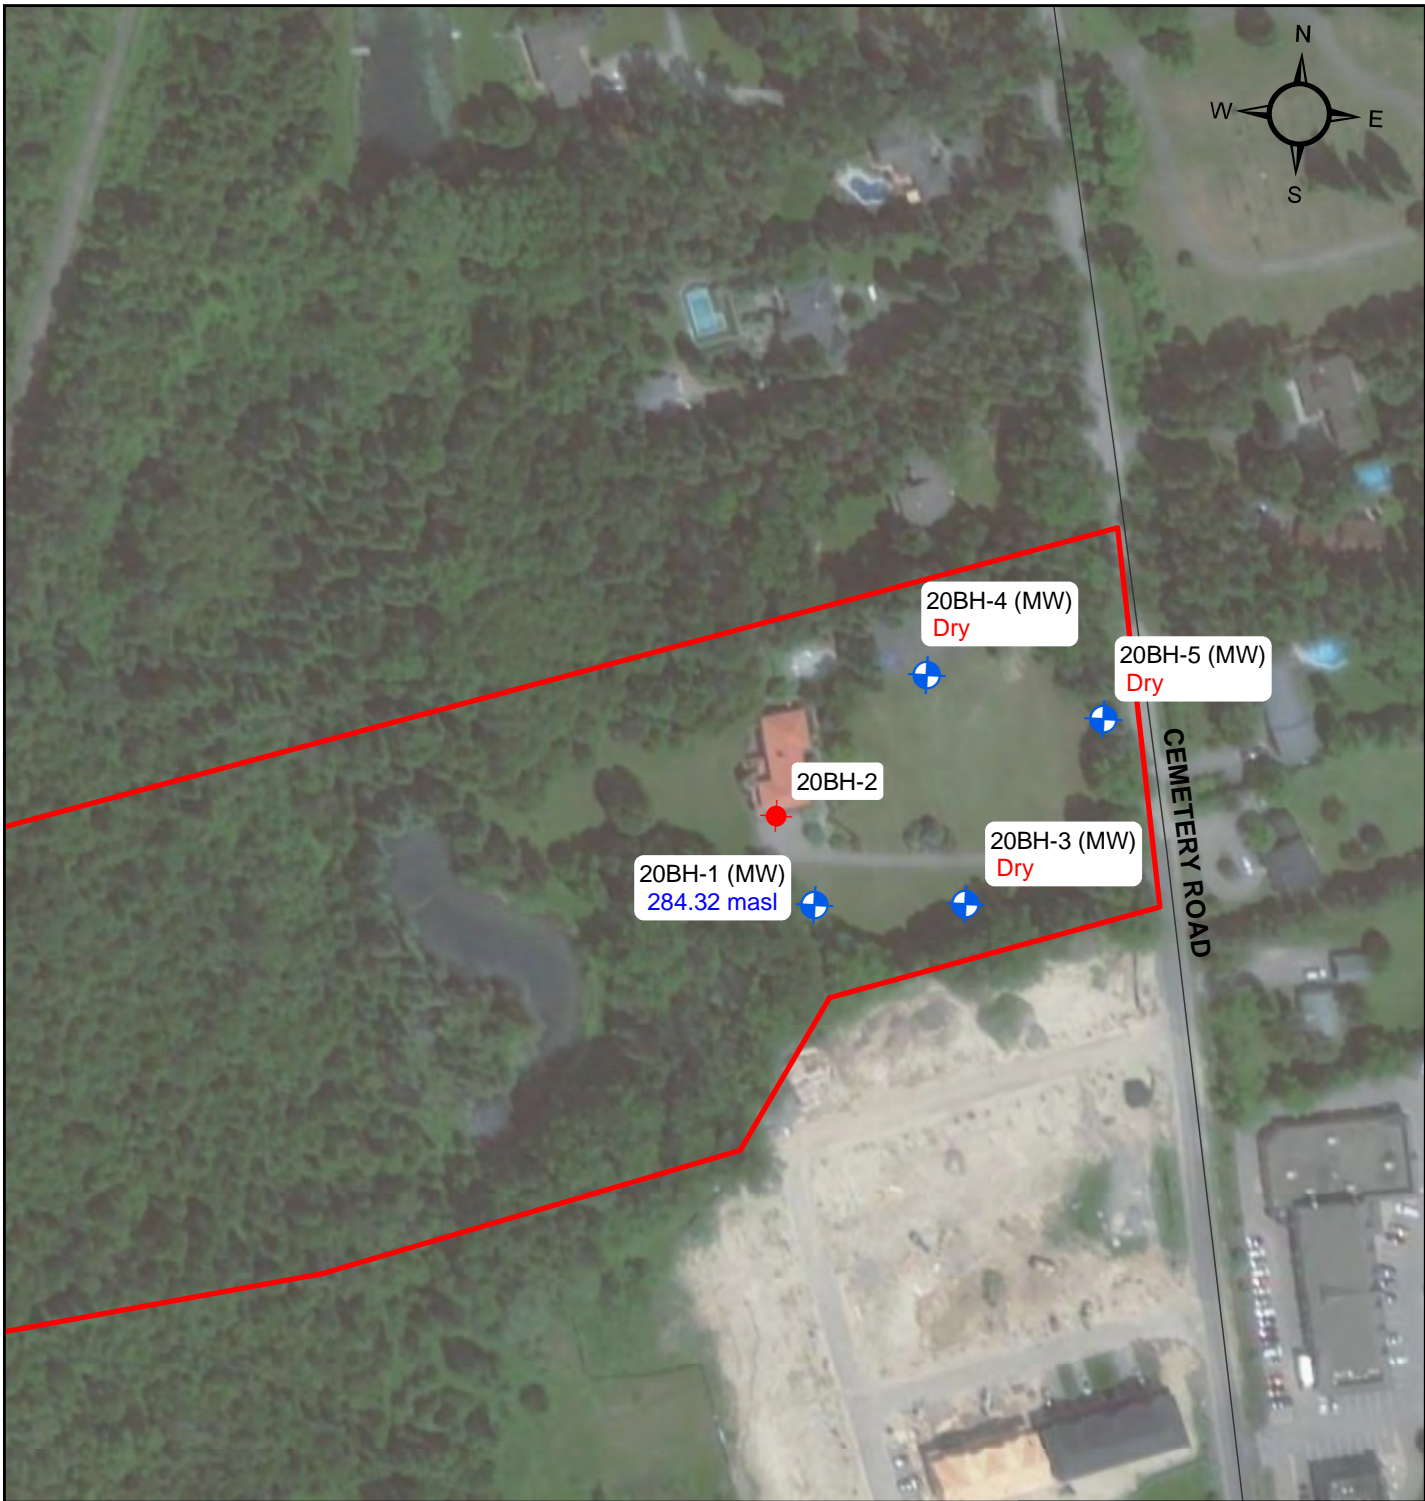
TITLE: Boreholes and Monitoring Wells		
LOCATION: 150 Cemetery Road, Uxbridge, Ontario		
PROJECT NO. 5431W-20-HB	DATE: February 2021	FIGURE NO. 8

XXX.XX masl (Groundwater Elevation Measured on January 5, 2021)

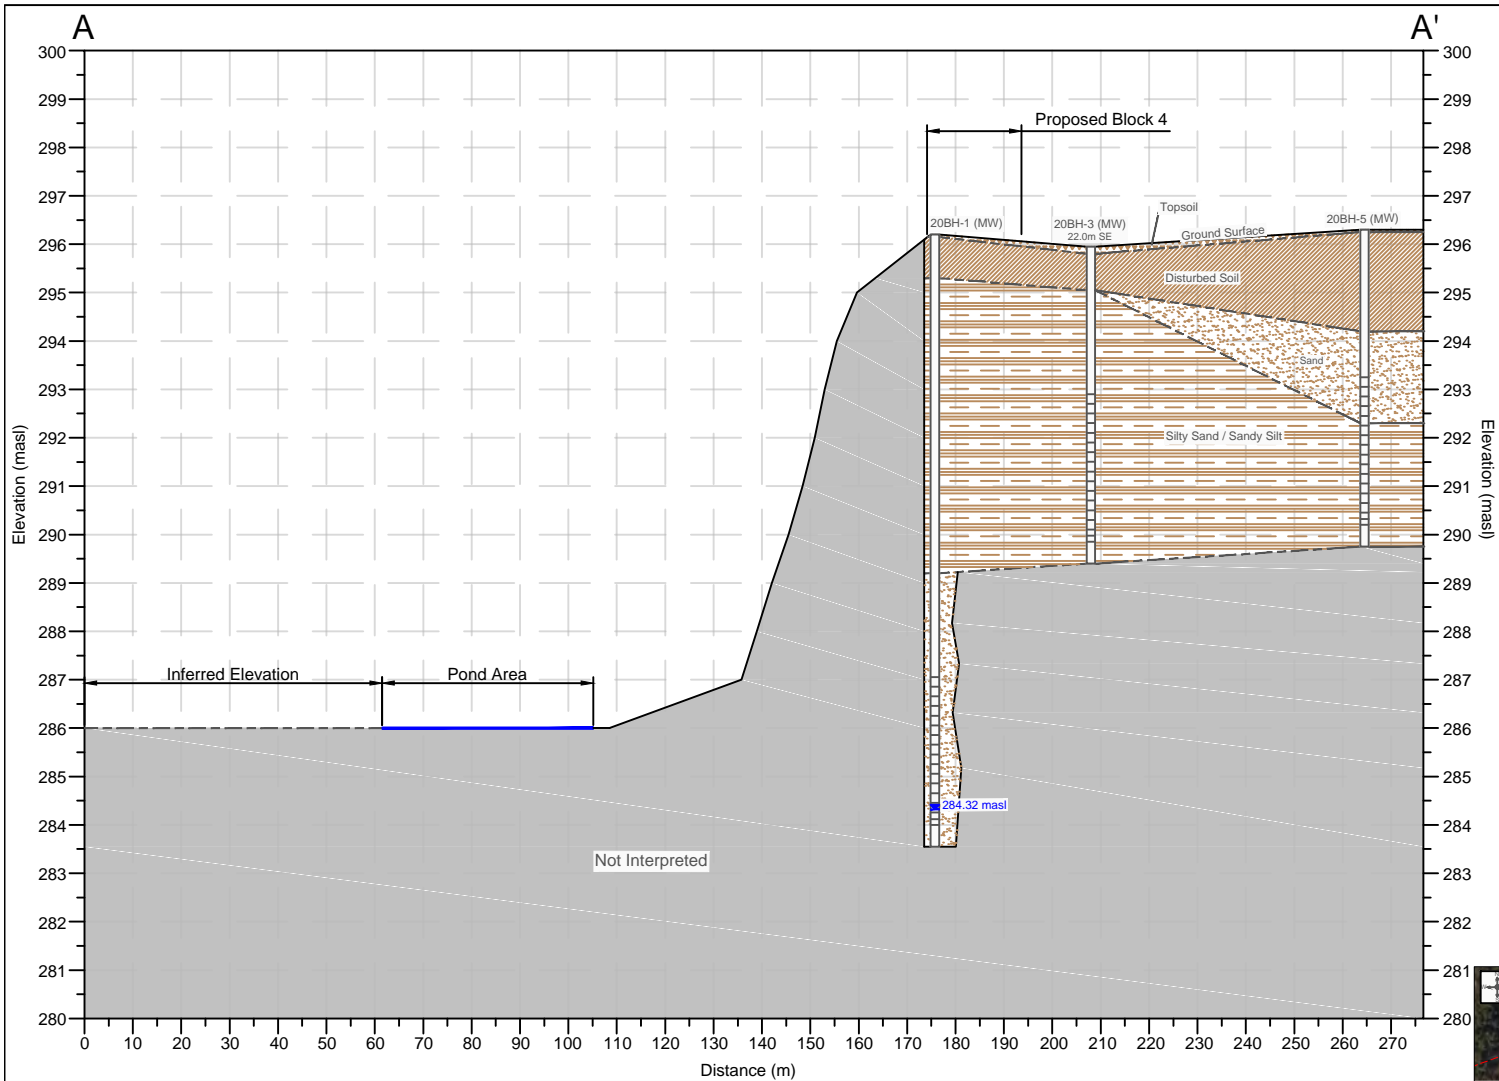
TITLE: Local Geological Section A-A'		
LOCATION: 150 Cemetery Road, Uxbridge, Ontario		
PROJECT NO. 5431W-20-HB	DATE: February 2021	FIGURE NO: 9

- Topsoil
- Disturbed Soil
- Silty Sand / Sandy Silt
- Sand
- Water Level Measurement masl (1/5/2021)
- Inferred Geological Boundary
- Section A-A'
- Site Boundary
- Borehole and Monitoring Well Location
- Monitoring Well Screen

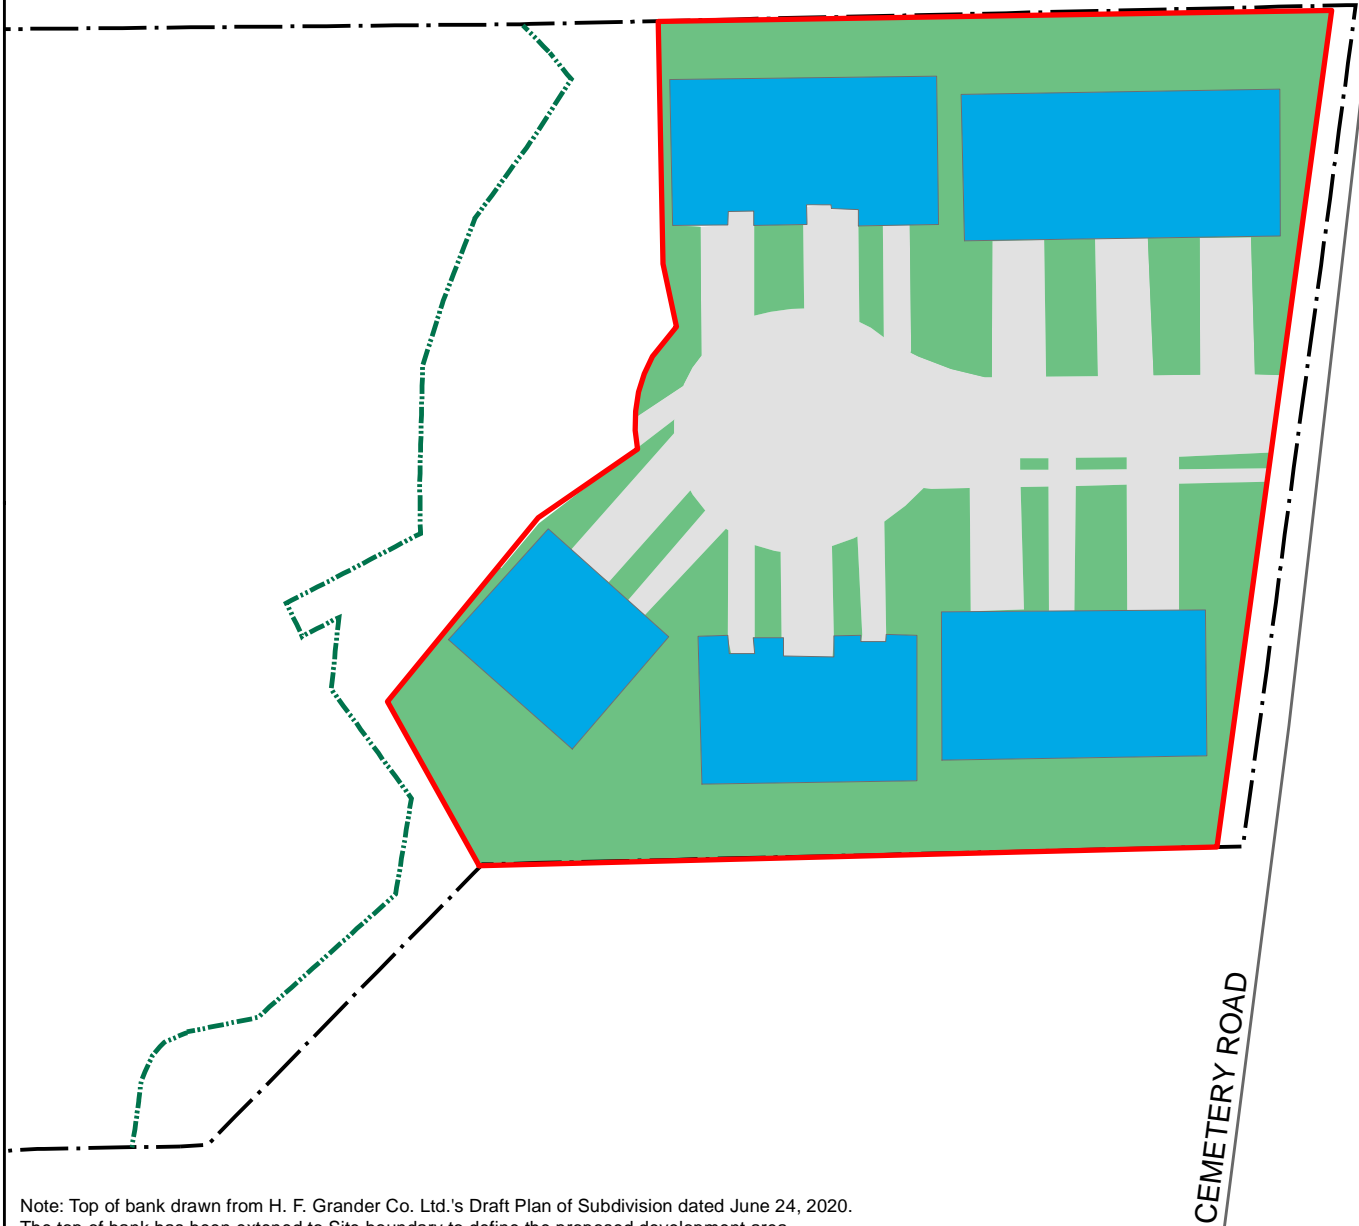
TITLE: Post-Development Water Balance		
LOCATION: 150 Cemetery Road, Uxbridge, Ontario		
PROJECT NO. 5431W-20-HB	DATE: February 2021	FIGURE NO. 11

Note: Top of bank drawn from H. F. Grander Co. Ltd.'s Draft Plan of Subdivision dated June 24, 2020. The top of bank has been extended to Site boundary to define the proposed development area.

Area ID			Area (m <sup>2</sup> )	MOECC Infiltration Factors	Runoff Factors
Pre-Development	S1	Grass Area	7,118	0.5	0.5
	S2	Paved Area	852	0	0.9*
Post-Development	S1	Grass Area	3,155	0.6	0.4
	S2	Paved Area	2,290	0	0.9*
	S3	Building Area	2,525	0	0.9*

The post-development water balance without mitigation showed an increase in surface runoff and reductions in evapotranspiration and infiltration due to an increase in impervious area. In the post-development scenario, infiltration represents 8% of the total precipitation, runoff represents 60% of the total precipitation, and evapotranspiration represents 32% of the total precipitation. Based on the water balance analysis, the estimated overall infiltration rate in the post-development scenario without mitigation is approximately 557 m<sup>3</sup>/year. The corresponding post-development infiltration deficit, assuming no mitigation, is approximately 490 m<sup>3</sup>/year, which represents a negative change of 47% from pre-development infiltration.

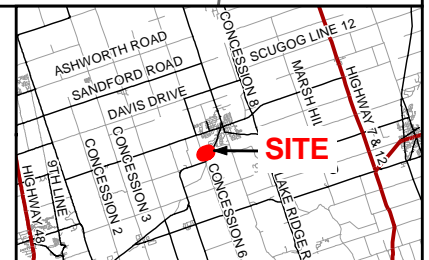
- Top of Bank
- Road
- Site Location
- Property Boundary
- Post-Development Building Area
- Post-Development Grass Area
- Post-Development Paved Area

Details of the water balance analysis are presented in **Appendix E**. The pre-development and post-development catchment areas are illustrated in **Figure 10** and **Figure 11**, respectively
