# **Hydrogeological Assessment to Support Townhome Development at 231, 235, 237, 241, 245 and 249 Durham Road No. 8 (formerly Reach Street), Uxbridge, ON**

*PECG Project #*  
170521

*Prepared For*  
2452595 Ontario Ltd.

March 18, 2019

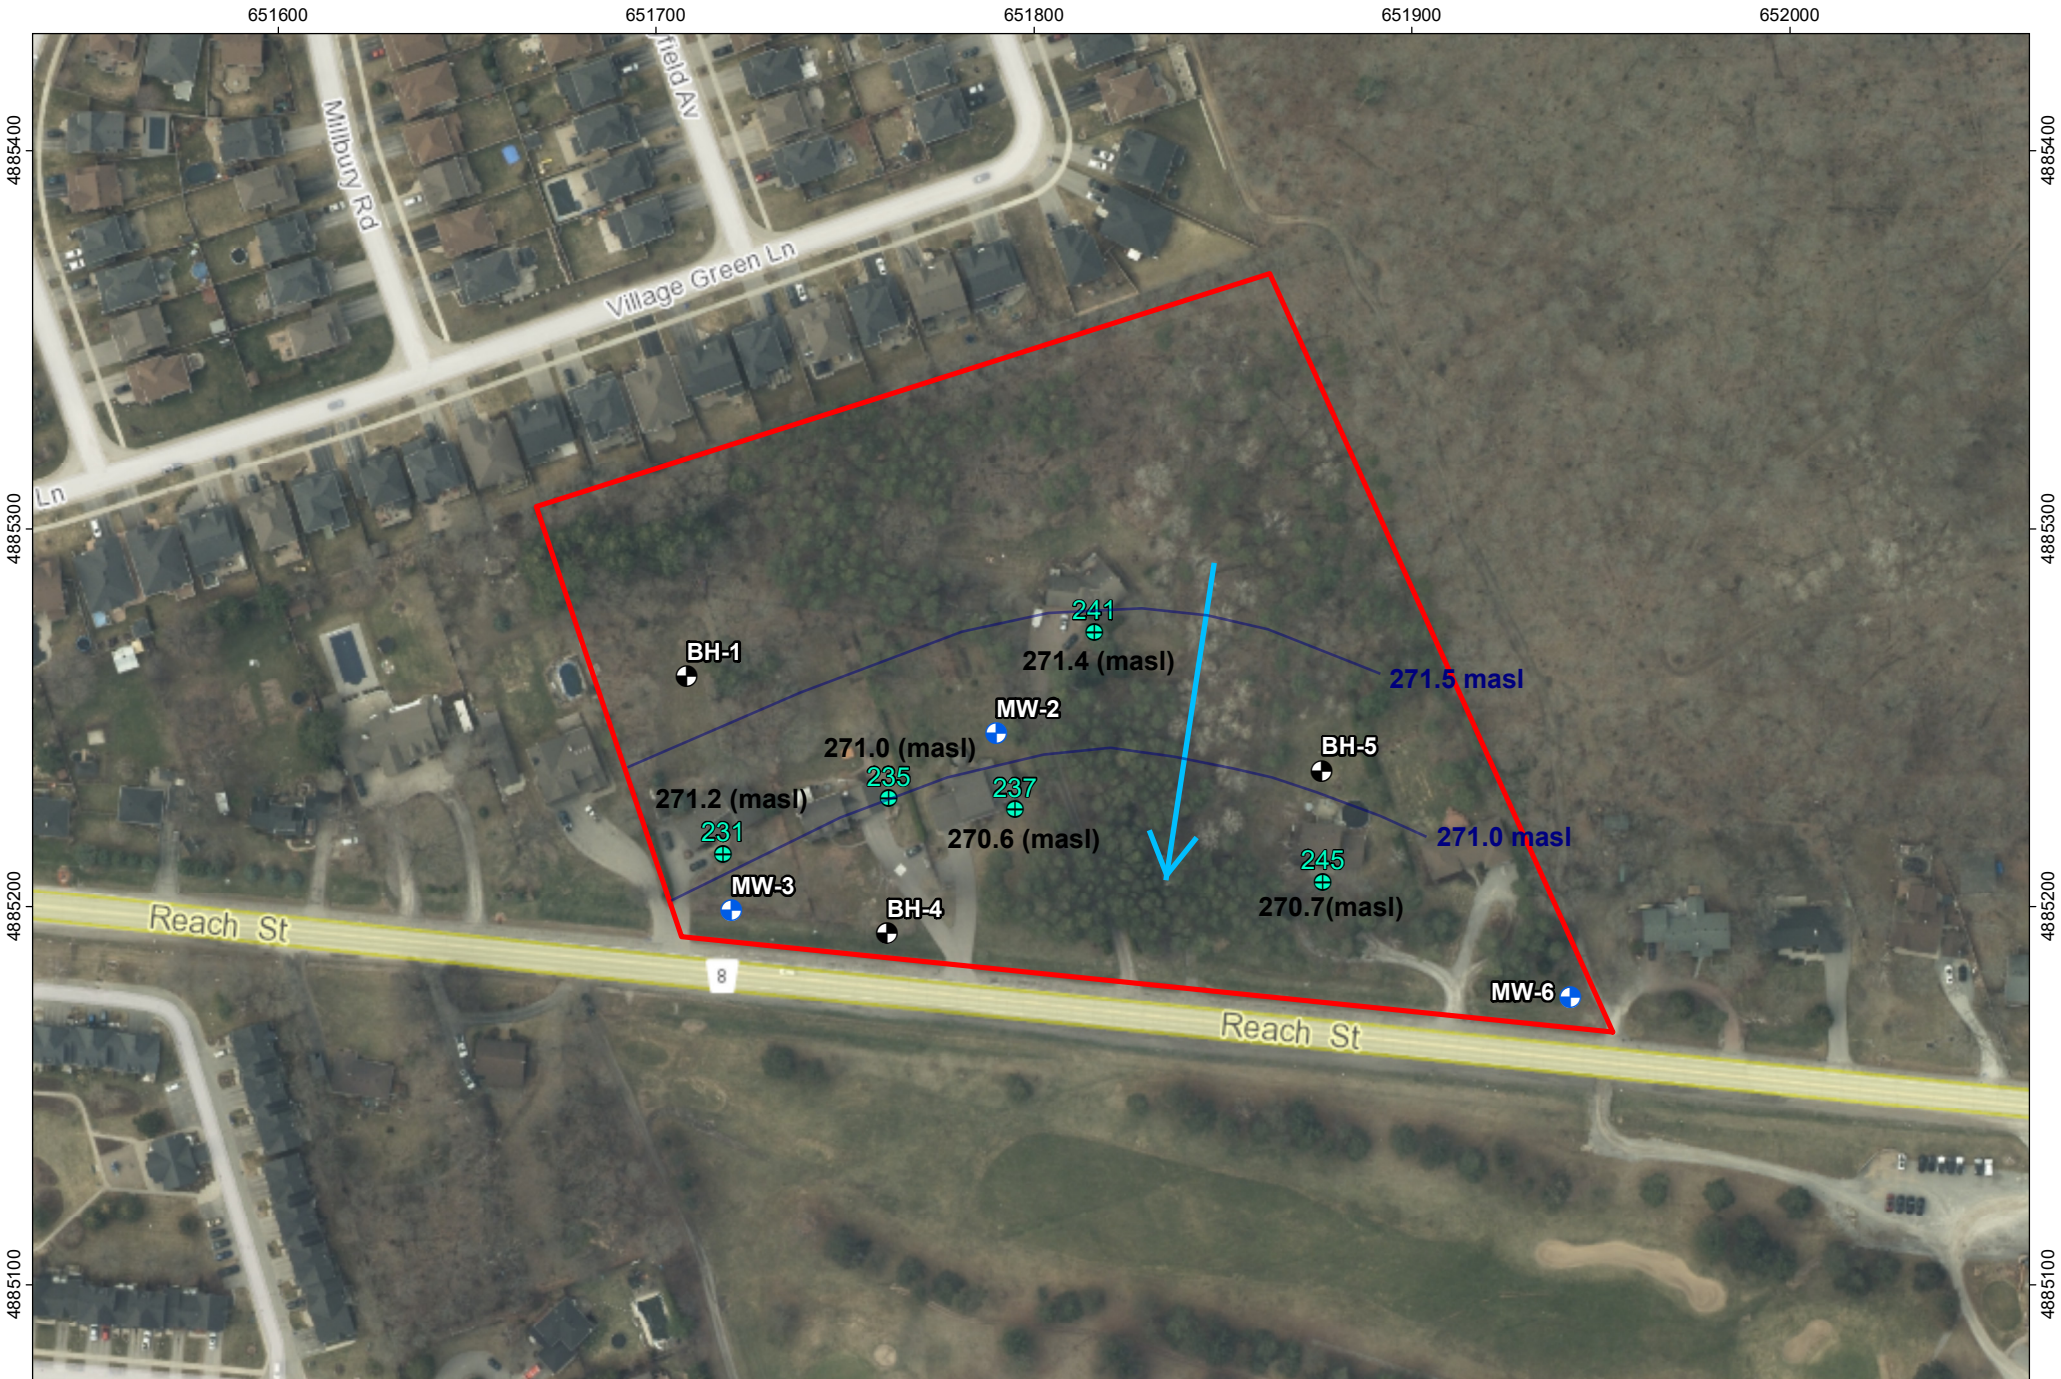
The groundwater flow direction can be estimated using the groundwater elevations obtained from the monitoring events displayed in **Table 4**. Groundwater flow at this site is directed to the south towards Uxbridge Brook (**Figure 5**).

It is expected that the 98% increase in infiltration will have an overall positive impact on natural conditions in the area. Based on the direction of groundwater flow within the site, shown in **Figure 5**, infiltration will be directed south towards Uxbridge Brook, and the associated Uxbridge Brook Headwaters Wetland Complex. The headwaters of Uxbridge Brook are supported by groundwater discharge, and this reach is known to support coldwater fish habitat (LSRCA, 1997).
