PHASE I ENVIRONMENTAL SITE ASSESSMENT
231, 235, 237, 241, 245, 249 REACH STREET, UXBRIDGE, ONTARIO

Project: SP17-275-20-01
February 20, 2018
(revised on March 14, 2018)

1.0 EXECUTIVE SUMMARY

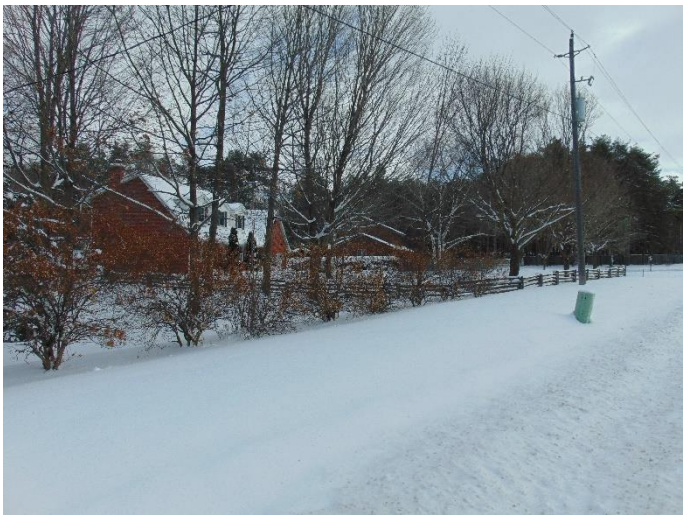
Photograph 1

Location:	Phase I Property
Viewing:	Northeast
Description:	View of the south portion of the Property

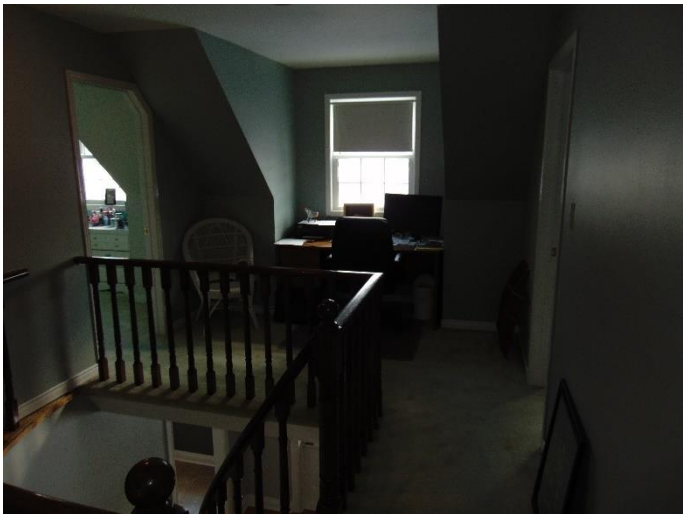
Photograph 14

Location:	Phase I Property
Viewing:	N/A
Description:	General view of the second floor of the building (235 Reach Street)

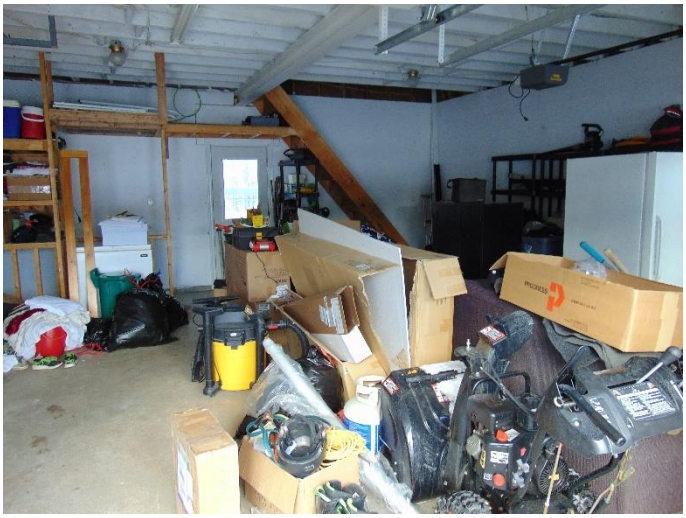
Photograph 15

Location:	Phase I Property
Viewing:	N/A
Description:	View of the garage of the building (231 Reach Street)

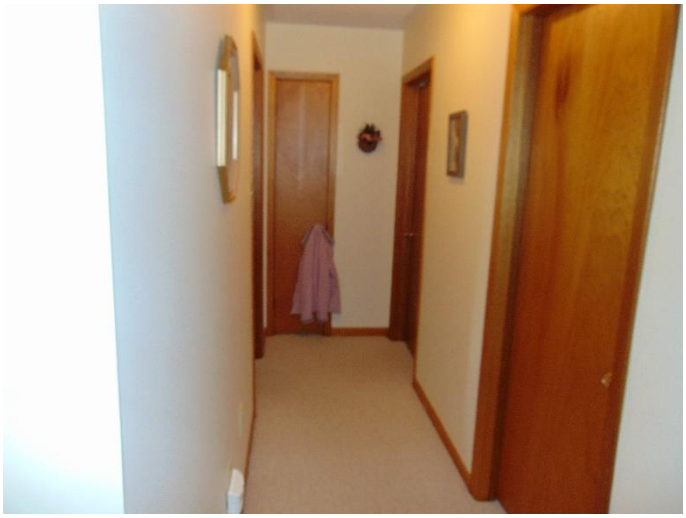
Photograph 24

Location:	Phase I Property
Viewing:	N/A
Description:	General view of the second floor of the building (237 Reach Street)

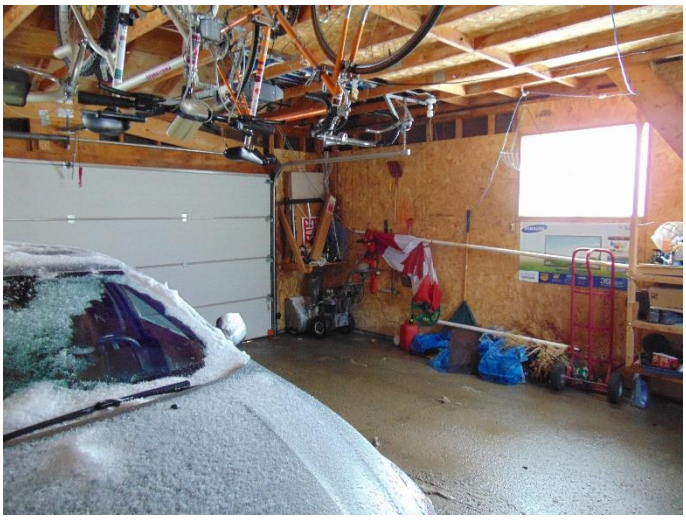
Photograph 25

Location:	Phase I Property
Viewing:	N/A
Description:	View of the garage of the building (237 Reach Street)

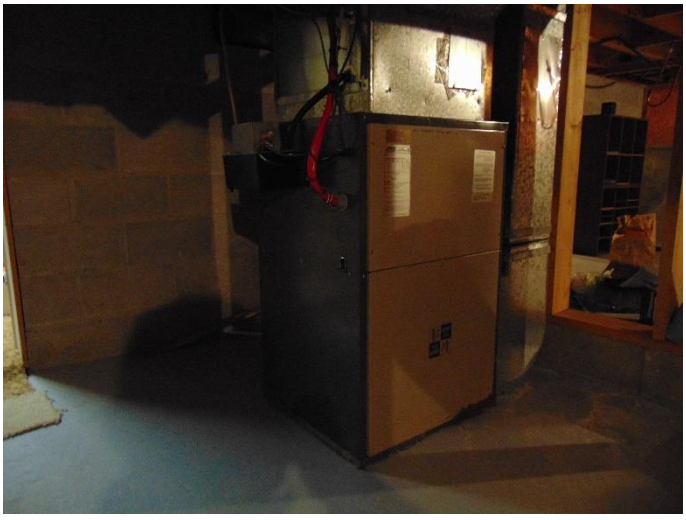
Photograph 27

Location:	Phase I Property
Viewing:	N/A
Description:	View of the electric furnace in the basement of the building (237 Reach Street)

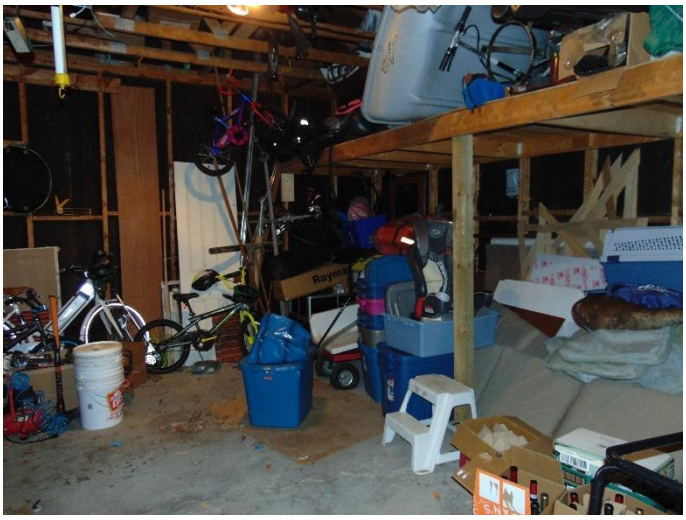
Photograph 31

Location:	Phase I Property
Viewing:	N/A
Description:	View of the interior of the shed located to west of the residential building (241 Reach Street)

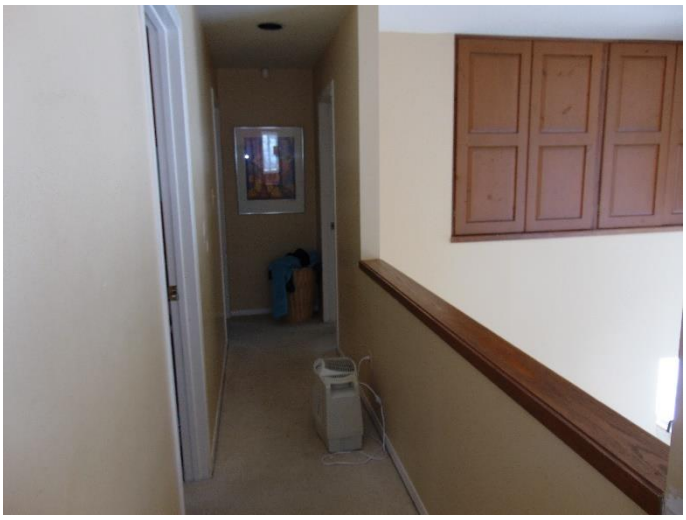
Photograph 34

Location:	Phase I Property
Viewing:	N/A
Description:	General view of the second floor of the building (231 Reach Street)

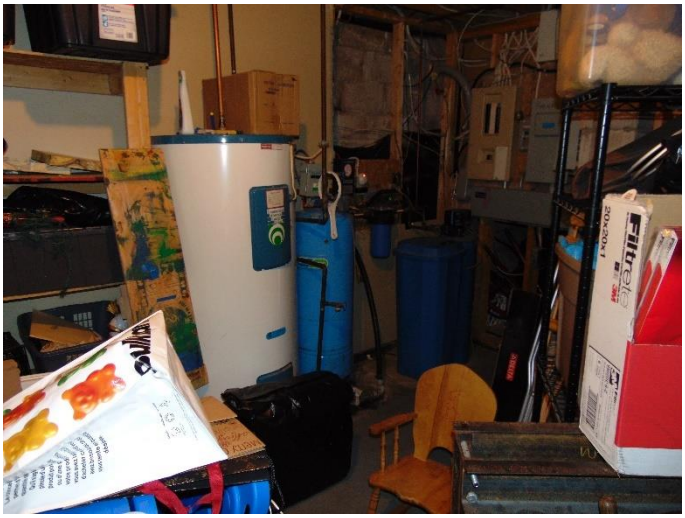
Photograph 38

Location:	Phase I Property
Viewing:	N/A
Description:	View of the hot water tank in the basement of the building (241 Reach Street)

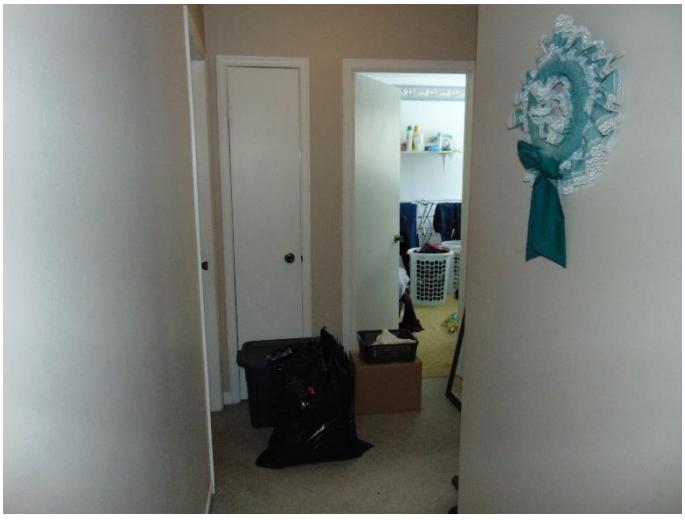
Photograph 44

Location:	Phase I Property
Viewing:	N/A
Description:	General view of the second floor of the residential building (245 Reach Street)

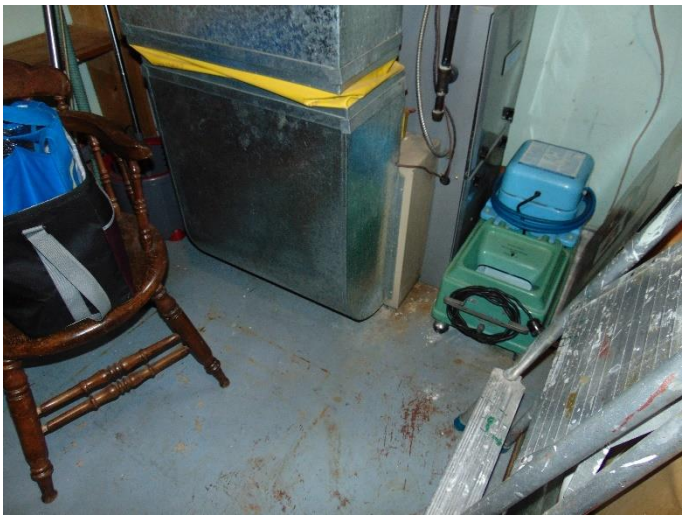
Photograph 47

- Based on the site reconnaissance, visible signs as tank and standpipe marks in the basement and on the west wall of the residential building located at 245 Reach Street suggest the presence of an AST in the basement of the building. No stain or odor were noticed on the floor within the tank storage area and the concrete stairs immediate adjacent to the west wall where the former fueling vent pipe was located. In addition, no crack was noticed on the concrete floor.

Location:	Phase I Property
Viewing:	N/A
Description:	View of the location of the former aboveground storage tank located in the basement of the building (245 Reach Street)

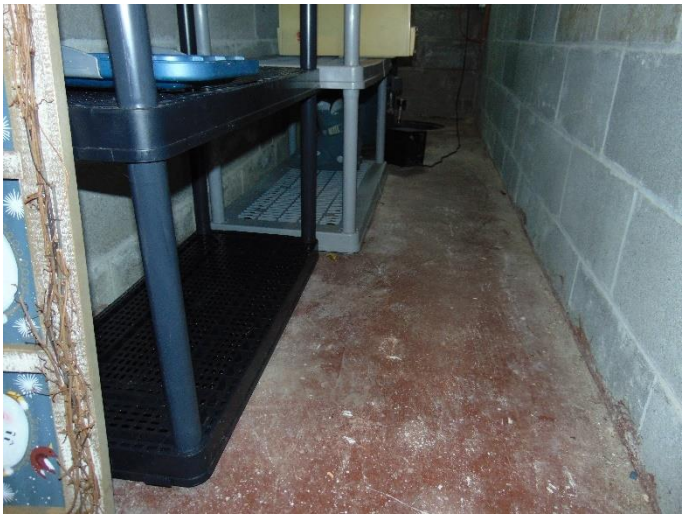
Photograph 48

No aboveground storage tanks were observed at the Property. However, visible signs as tank and standpipe marks in the basement and on the west wall of the residential building located at 245 Reach Street suggest the presence of an AST in the basement. No stain or odor were noticed on the floor within the tank storage area or concrete stairs immediate adjacent to the west wall where the former fueling vent pipe was located. In addition, no crack was noticed on the concrete floor.

Location:	Phase I Property
Viewing:	N/A
Description:	View of the concrete floor of the room that stored the former aboveground storage tank located in the basement of the building (245 Reach Street)

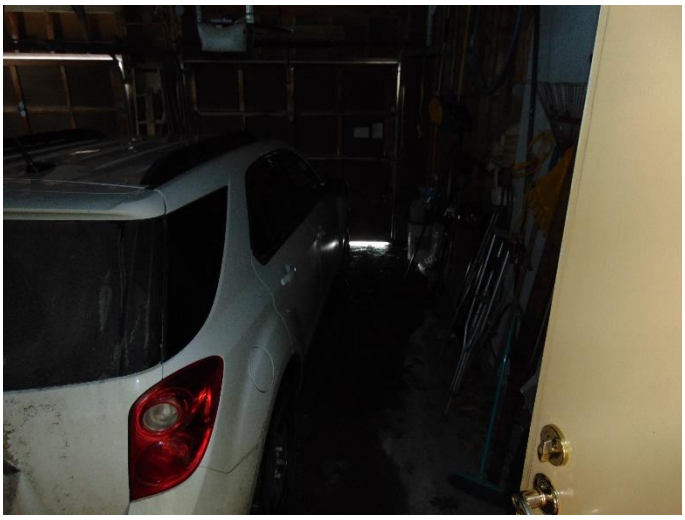
Photograph 55

Location:	Phase I Property
Viewing:	N/A
Description:	General view of the garage of the building (247 Reach Street)

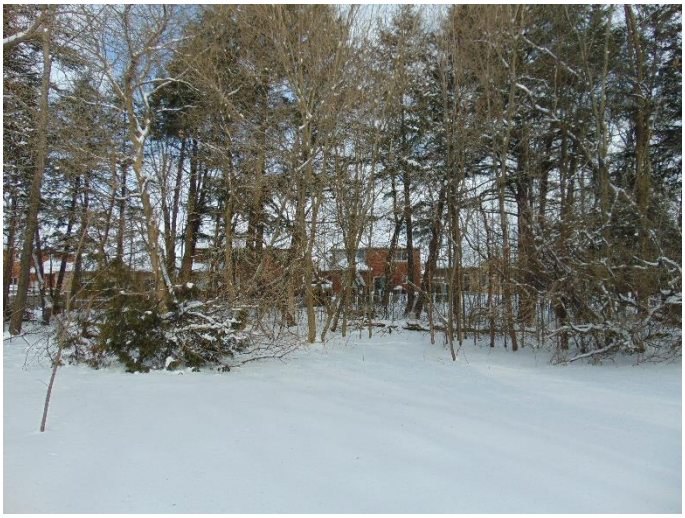
Photograph 60

Location:	Phase I Property
Viewing:	North
Description:	View of the neighboring properties to the north
