# Stormwater Management Ponds

## Township of Uxbridge

Stantec conducted an assessment of twenty two (22) stormwater management (SWM) facilities within the Township of Uxbridge in 2012 to assist the Township in prioritizing maintenance activities.

**Stormwater Management Pond Example:**  
SWM Pond 1E, Industrial Park East

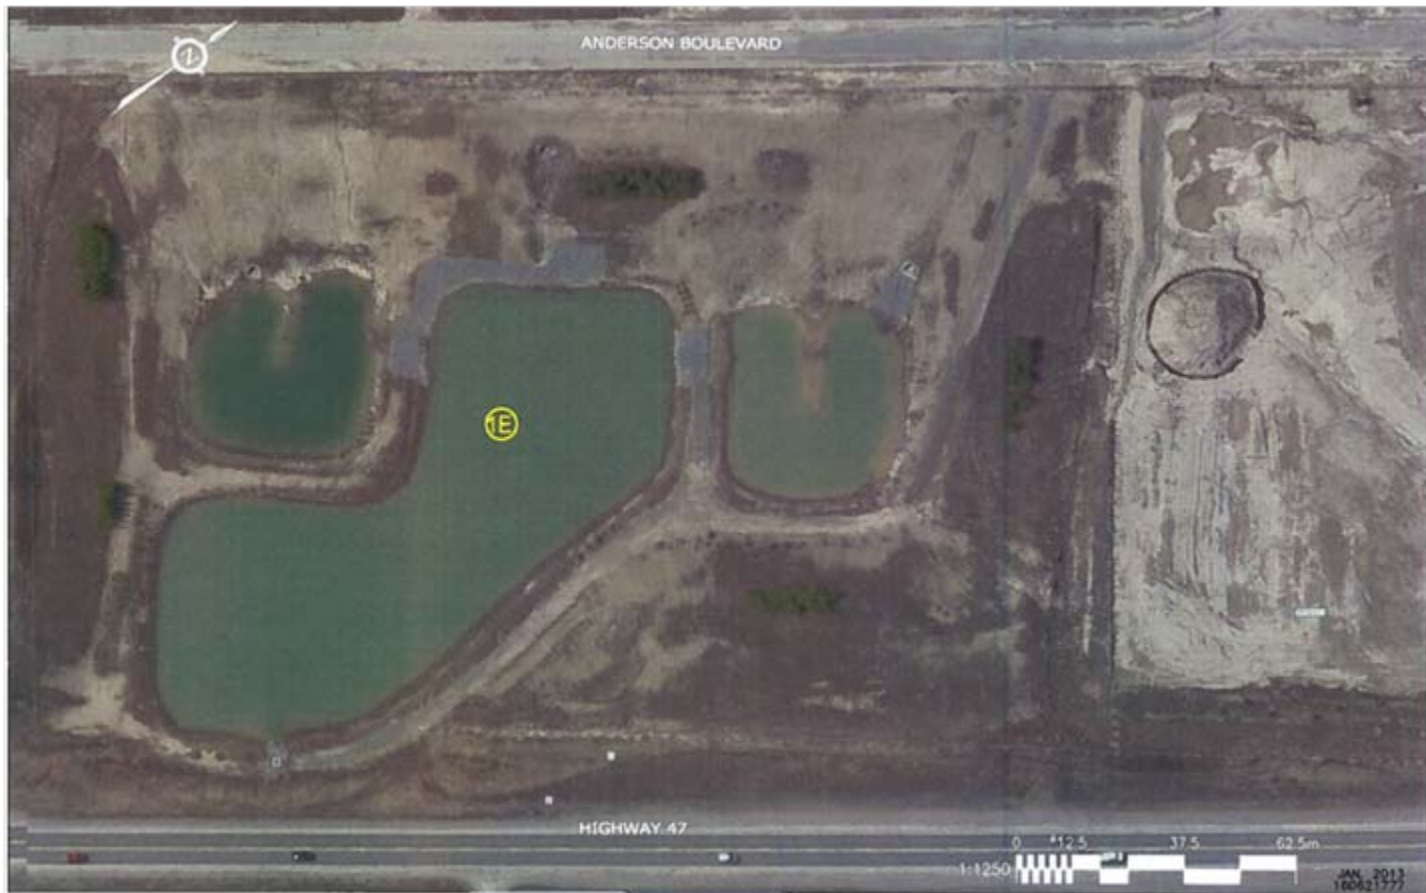
Maintenance Access Road	Has a maintenance access road been provided? What material is the road made up of? Is there clear access from the municipal roadway? Is the road provided around the entire pond? What SWM pond features does the road allow for easy access? Circle all that are accessible. Does the road extend to the bottom of the forebay?	<u>Forebay</u> <u>Inlet HW</u> Afbay Outlet Structure(s) Outlet HW Em. Spwy Other?	A granular maintenance access road is provided off of Anderson Boulevard. It provides access to the east inlet headwall and forebay, as well as the outlet structure. More granular material was recently placed on the access road within the ROW and on the steep sloped section of the road. Within the ROW, the granular covers the curb and gutter, no curb cut was provided. There is significant amount of erosion (holes) at the base of the slope. As the road wraps around the east forebay toward the outlet structure, it 'disappears', became very overgrown with vegetation.

Signage	Has a SWM pond warning sign been installed? Any other signage related to SWM?	No	
Fencing	Has a safety fence been installed around the pond? Is there a locked gate prohibiting access?	No	
Sediment Drying Area	Has an area been provided for sediment de-watering?	No	
Inlet Structures	Structural integrity of headwall/pipes (cracked, broken, separated, grate secure, etc.) Are pipes clear of debris and/or sediment? Is there erosion protection? If so, what is the approx. mean diameter of the stone? (Photo document)	Yes	The pond has three inlets , two storm sewer inlets, east and west headwall, as well as a culvert inlet, central headwall. The east inlet headwall is in good repair, pipe is free of debris, the pedestrian handrail is secure, however, the grate is loose and needs to be tightened. The erosion protection for this headwall consists of rip rap embedded in concrete, a lot of the rip rap has been dislodged and at the waters edge, the ground beneath the concrete has been eroded leaving a gap between the ground and the concrete. The central headwall (box culvert) is in good repair, grate and pedestrian handrail secure.

Item	Criteria/Maintenance Item	Y/N	Notes
Inlet Structures	Con't		There is approximately 0.3 m of accumulated sediment and vegetation growth within the headwall bottom (a tree is actually growing in it), the downstream side of the culvert has accumulated sediment in it (not measured as difficult to access), however the upstream side of the culvert has little sediment accumulated in it. Gabion baskets are located around the wing walls. No erosion protection visible. The west headwall is in good repair, grate and pedestrian handrail secure, there is a slight gap in the handrail which is corroding however as mentioned it is still secure. Inlet pipe is clear of debris, however, some minor sediment accumulation at wingwalls. Some erosion protection visible beneath the water surface.
Overland Flow Route	Is the facility equipped with an overland flow route? If so, is it in good repair? Vegetated or hardened? (Photo document)	No

Infiltration Basin	Is the facility equipped with an infiltration basin? If so, describe.		
Outlet Structure	Are there any visible control structures (hickenbottom riser pipe, orifice plates/tubes, DICB grates, etc.) If so, what are their condition? Is outlet headwall/pipe clear of debris and/or sediment? Is there erosion protection? If so, what is the approx. mean diameter of the stone? (Photo document)	Yes	The outlet structure is comprised of a 200mm PVC inlet pipe, a DICB MH (grate is sloped and it's dimensions are 0.6 m wide x 1.2 m) and CMP outlet pipe complete with a rip rap plunge pool (located on south side of Highway 47). All of which are in good repair.
Emergency Spillway	Is the facility equipped with an emergency spillway? If so, is it in good repair? Vegetated or hardened? (Photo document)	No	
Permanent Pool Water Level	Is the pond level higher than the normal permanent pool elevation > 24 hrs after a storm? Is the pond level lower than the normal permanent pool elevation? What are possible causes for water level (blocked inlet/outlet)?		Water level is normal.

Item	Criteria/Maintenance Item	Y/N	Notes
Forebay/Aftbay	Is there a defined forebay and aftbay? Is there a forebay berm? If so, is it submerged? (Photo document)		There are two defined forebays and one aftbay between the two. The forebay berms are raised, lined with rip rap on the downstream side (adjacent to the aftbay). Vegetation is growing within the rip rap and some erosion matting is exposed on the east berm. Each berm is equipped with two PVC pipes, on the upstream side of the berm the pipes are fully submerged and on the downstream side the pipe inverts are set at the normal water level. All the pipes are in good condition.
Permanent Pool Water Depth	Approximate permanent pool depth? Is there significant sediment accumulation in the forebay? Aftbay? Estimated depth of sediment in the forebay? Is a sediment cleanout likely necessary?		The permanent pool is deep. At the east inlet headwall, a lot of sediment has accumulated (up to normal water level). There is some accumulation at the west inlet headwall but not as much.

Liner	Is the pond lined? If so, describe.		No evidence of a liner.
Length to Width Ratio	Is pond geometry 3 L to 1 W OR has internal berming been used to increase effective flow length?		The pond geometry is at least 3:1. Both forebays have an internal submerged berm used to increase the forebay flow length (only slightly visible on the day of the inspections).
Water Quality	How clear is the water (turbidity level)? Is there any algae growth? Are there any noxious odours? Is there an aerator in pond?		The water was very brown in colour, ie. very sediment laden, however, no algae growth.
Oils/Floatables	Is there an oily sheen on the water near the inlet or outlet? Is the water frothy? Any unusual colouring of the water? If so then document - review the contributing drainage area for potential contamination and provide recommendation. (Photo documentation)	No

Item	Criteria/Maintenance Item	Y/N	Notes
Active Storage Depth	Approximate Active Storage depth? (Refer to engineering drawings)		There is a lot of active storage within the pond.
Side Slopes	What are the approximate side slopes within the SWM pond? Upstream embankment? Downstream embankment? Is there a safety bench graded at the normal water level?		Side slopes are approximately 3:1. a safety bench has been provided around the normal water level.
Erosion / Slope Stability	Are there any signs of erosion? Are there any signs of obvious slope instability (slumping, undercutting, rill/gully development)? (Photo document).	Yes	There is some minor gully development along the north side slope, adjacent to Anderson Blvd, however, the area is currently heavily vegetated which suggests that the erosion occurred prior to vegetation taking hold.
Vegetation	Is the vegetation established around the pond? Has it been maintained (cut, landscaped or is it overgrown)? Describe the vegetation around the permanent pool perimeter and the upland areas within the SWM pond block. (Photo document)		The pond is heavily vegetated, a lot of weeds present. There is a maintained path off an adjacent industrial parking lot to the normal water level but otherwise the pond block is very 'natural'.

Maintenance Recommendations		
<p><b>Required</b></p> <p>The pond appears to require a full sediment cleanout. Obtain a sediment survey to confirm the quantity of sediment to be removed. Repair undermined erosion protection at east inlet headwall. Place more rip rap at east forebay berm to cover exposed erosion matting.</p>		
<p><b>Recommended</b></p>		
Major Maintenance Activities Completed		
Item	Date Completed	Comments
Sediment Cleanout		Volume Removed (Forebay/Aftbay): Cleanout Method: Disposal Location: Cost \$/m3: Other Comments:
Vegetation/ Landscape		
Structural Improvements		
Other
